ONDERZOEKSRaad
VOOR VEILIGHEID

Mortierongeval Mali 2016

Heropening onderzoek 2022

Den Haag, augustus 2022

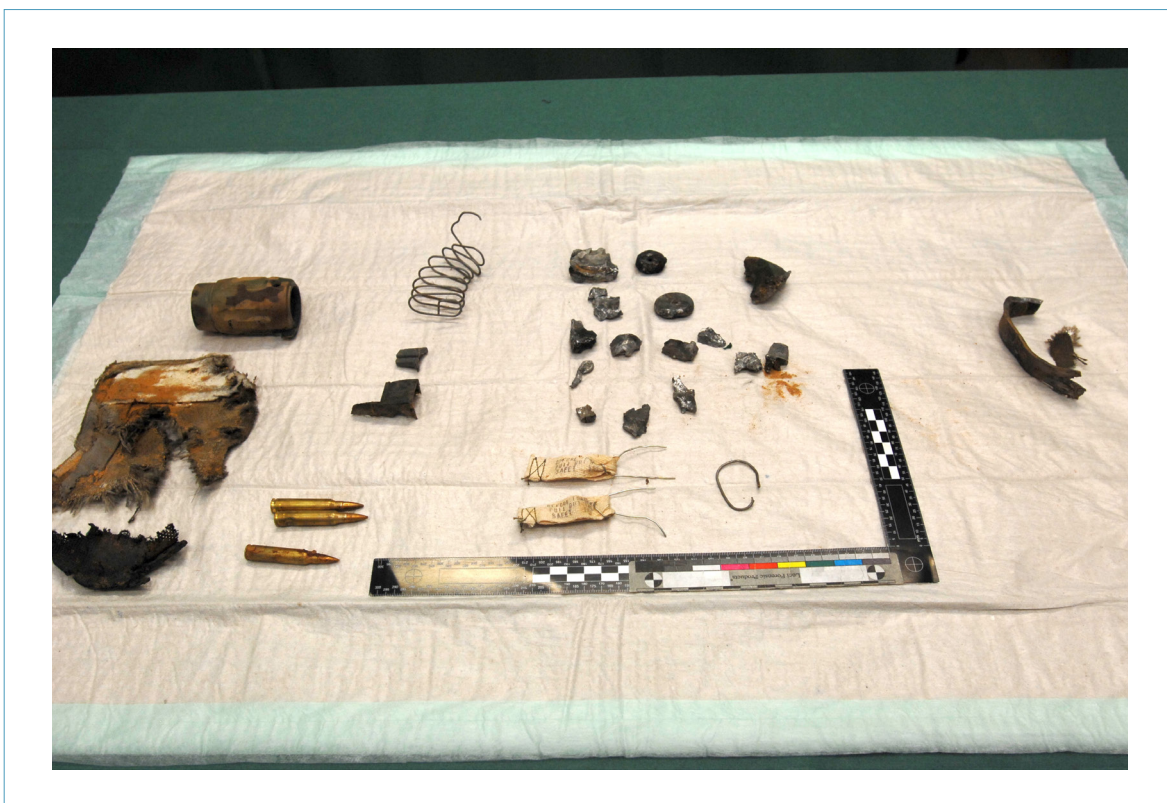
Figuur 2: de inhoud, verzameld bij de zoekslag vóór het vernietigen van de vijf granaten²²

Uit deze gereconstrueerde gang van zaken kan worden opgemaakt dat de granaatscherven en restanten in de bruine zak, die op 8 juli 2016 is afgeleverd bij de KMar in Gao, niet anders geduid kunnen worden dan als de granaatscherven en restanten die op 6 juli 2016 zijn verzameld tijdens de zoekactie direct na het ongeval. Ook kan worden uitgesloten dat tijdens de zoekactie direct na het ongeval de granaatscherven van de vóór het ongeval vernietigde blindganger zijn opgeraapt. De blindganger was terecht gekomen op ongeveer 500 meter afstand van de ongevalslocatie zonder te detoneren. Het zoekgebied van de ongevalsgranaat op de ongevalslocatie besloeg 100x100 meter.

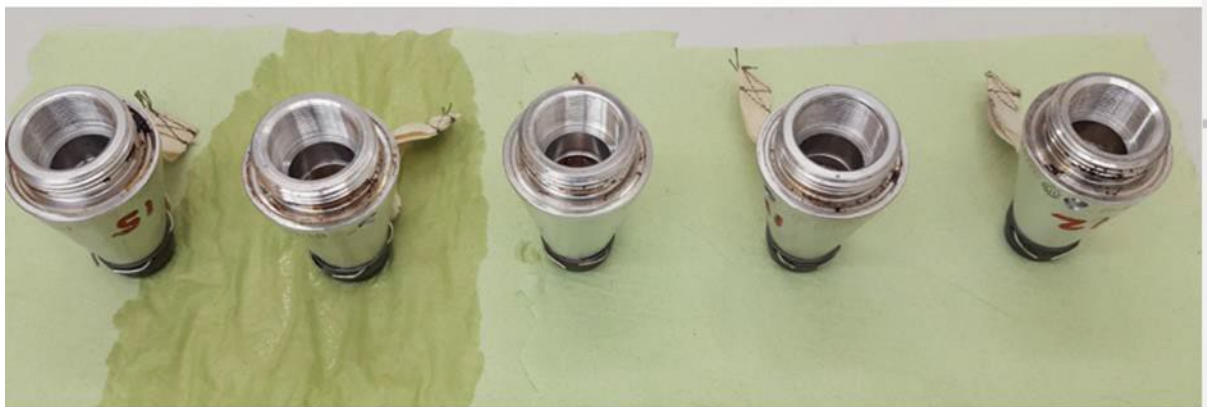
Figure 16: Filling the top of the M6-N fuze with water to show leakage. The adhesive layer of one of the five fuzes tested is leaking after a drop test from about one metre height with random impact orientation. (Picture: TNO)

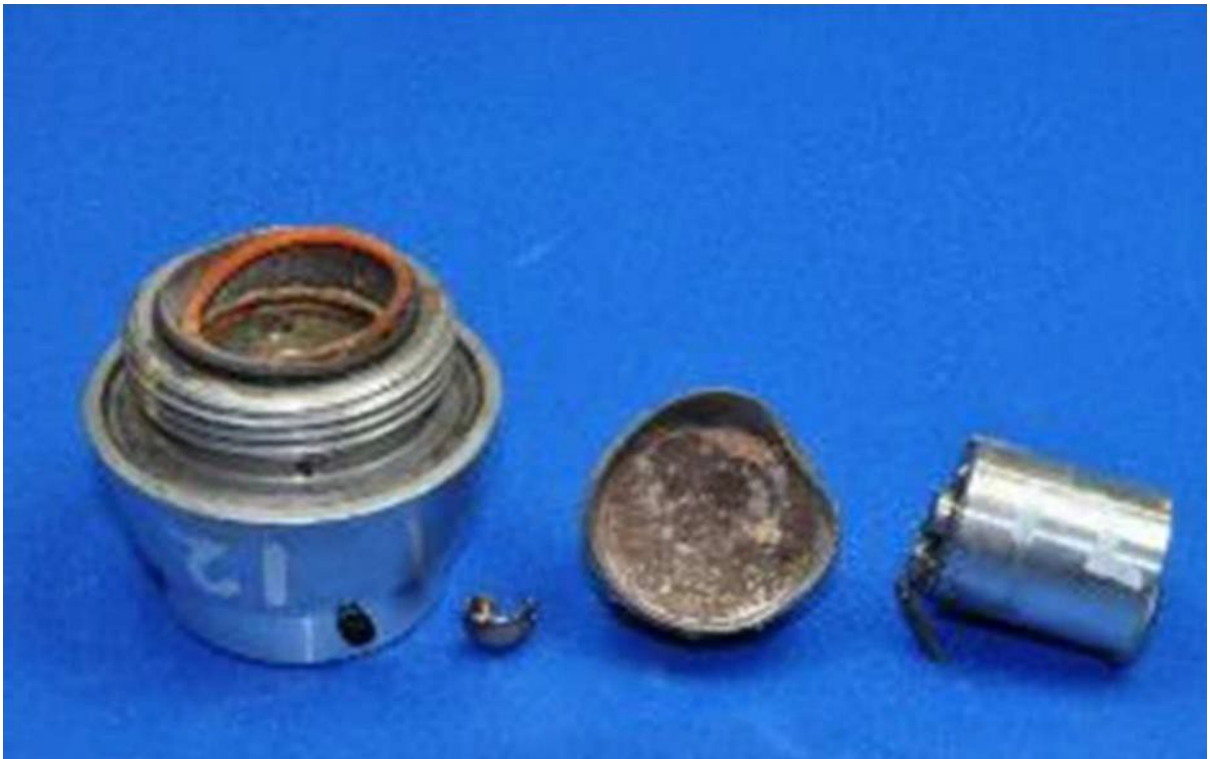
Figure 34: Explosive train interruption test carried out at 63°C by KC W&M. The booster charge has not detonated but it has fully combusted. In a higher confinement condition, as in an HE 80 round, transition to detonation may have occurred. (Picture: KC W&M)
