ONDERZOEKSRaad
VOOR VEILIGHEID

Mortierongeval Mali 2016

Heropening onderzoek 2022

Den Haag, augustus 2022

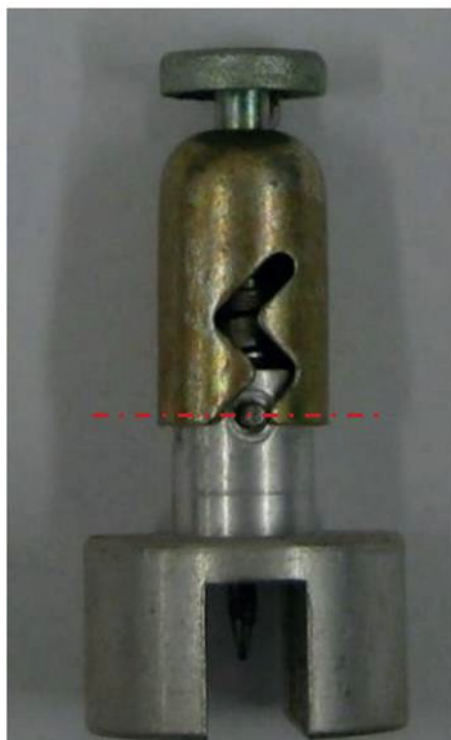
Figure 24: M6-N fuze mechanism composed of correctly positioned zigzag cross-pin at the beginning of the first "knee" of the zigzag slot (Picture: TNO)

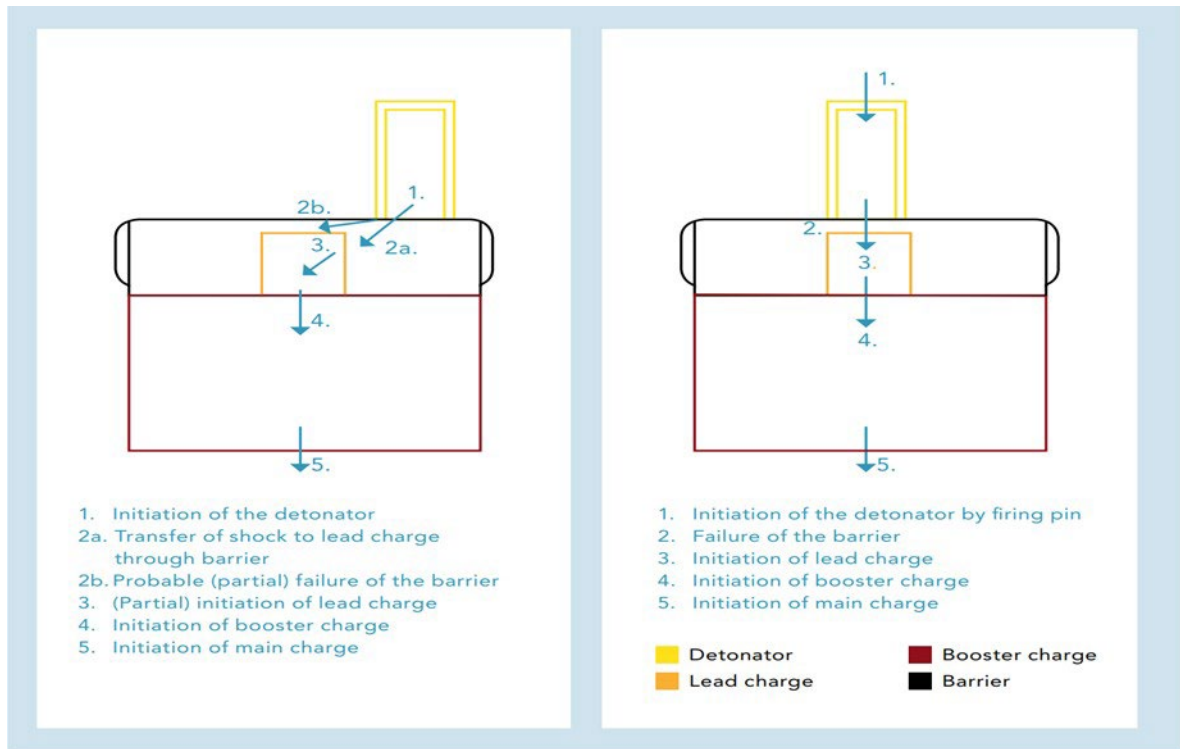
The failure to initiate the booster in the two TNO trials (carried out at 12°C) where a booster charge was fitted, and in a later single repeat trial carried out at 70°C [5, Appendix J] in closer emulation of the accident condition, causes reasonable doubt in the 'safe' position detonation mechanism (shown on the left-hand side of Figure 33). In contrast, every test of the M6-N fuze with the detonator in the armed condition produced full detonation of booster and main charge (where fitted) and there is no doubt from the photographic and physical evidence that the accident was such a detonation. To explore this issue further, KC W&M carried out 30

One possibility may be that the key variable is the extent to which the energy of the lead/booster charge is partitioned between deflagration and detonation. When the detonator is in the armed position (Figure 33, right hand side), the PETN booster is efficiently detonated, maximum shock energy is transmitted to the booster which detonates in turn. Where the

Figure 33: Explosive train for an unarmed fuze (left) and an armed fuze (right). (Source: TNO)
